SAINT PETER AND PAUL FEASIBILITY ASSESSMENT

The St. Peter and Paul Church, formerly the Everlasting Covenant Church, property on Larimer Avenue in the East Liberty neighborhood of Pittsburgh has been abandoned for a number of years. The site presently contains three buildings: the Church structure with frontage on Larimer Avenue, its connecting 2-1/2-story Rectory set back from Larimer Avenue, and a separate 3-story School at the rear of the property.

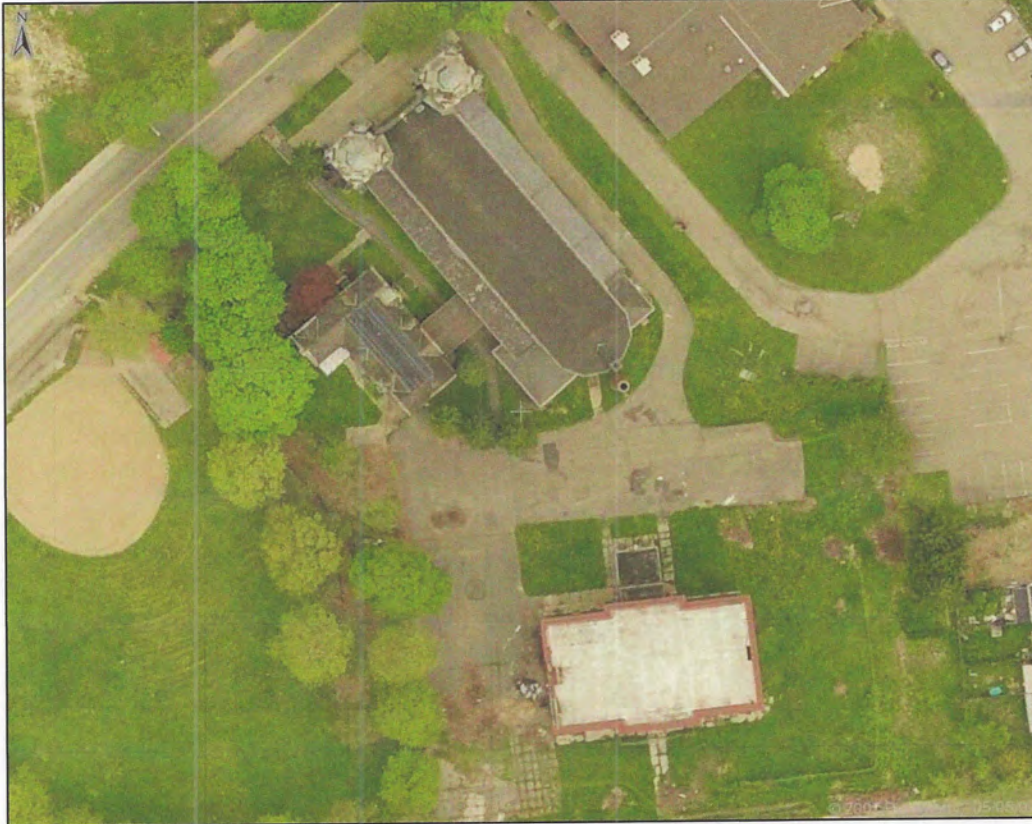
Top View

The following aerial images show various views of this structure for your reference.
